A GENTLEMAN'S GUIDE TO CLASSIC SMITHS ELECTRONIC TACHOMETERS

TRIUMPH OWNERS' CLUB
CHRISTCHURCH
NEW ZEALAND

Author: Alex Miller

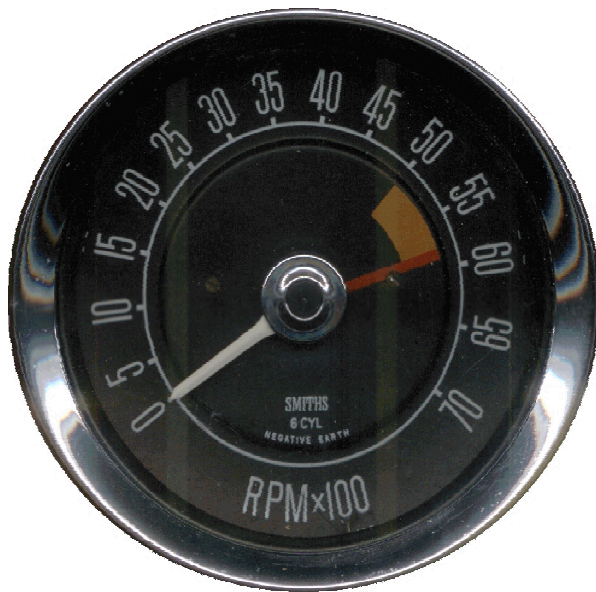
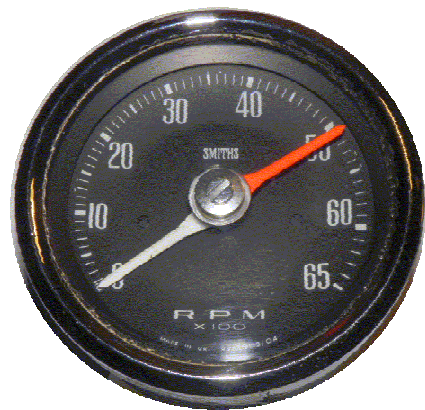
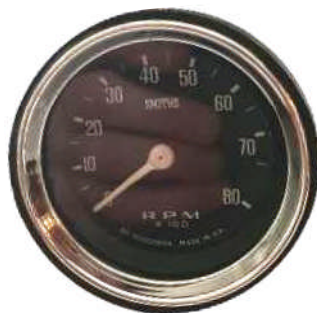
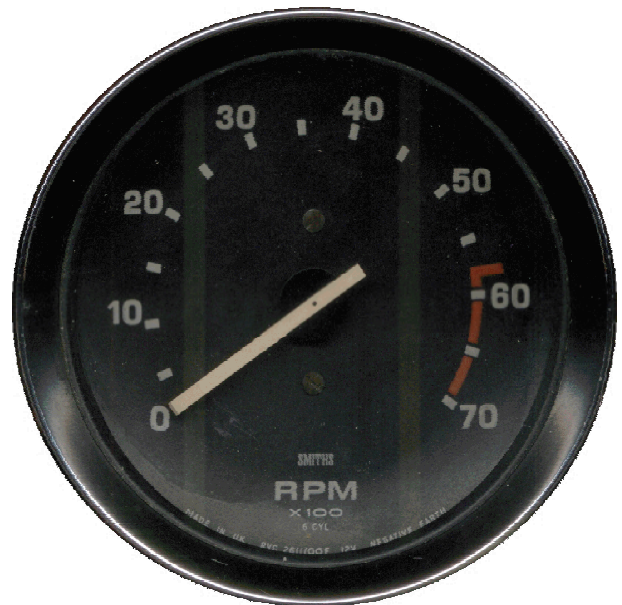
Top left – RVI 2631/00 Gen-2 Triumph 2.5 PI tachometer,

Top right – RVI 1003/04 Gen-1 accessory tachometer

Bottom left – RVI5000/00B Gen-2 accessory tachometer

Lower right – RVC2611/00F Gen-4 Triumph 2500S tachometer

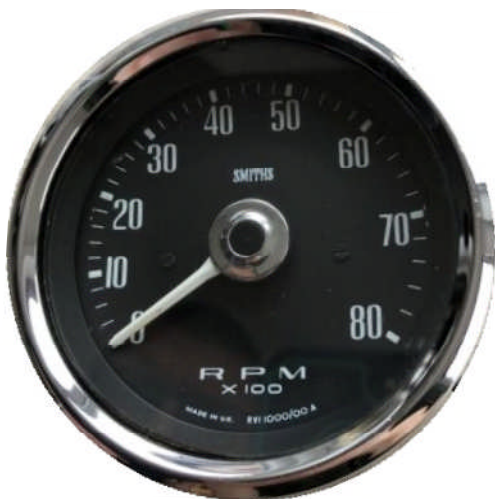
FIGURE 3.4: Gen-1 accessory tachometer. 3 inch diameter instruments produced with full scale readings of 6000, 6500, 7500, 8000 and 10000 rpm. Note that the tachometer shown below, a RVI 1000/00A (12V only), does not have the optional adjustable redline pointer that is shown on the RVI 1003/04 on the cover page. The RVI 1002/00(A) tachometer is the equivalent tachometer (8000 rpm fs) fitted with the adjustable redline pointer.

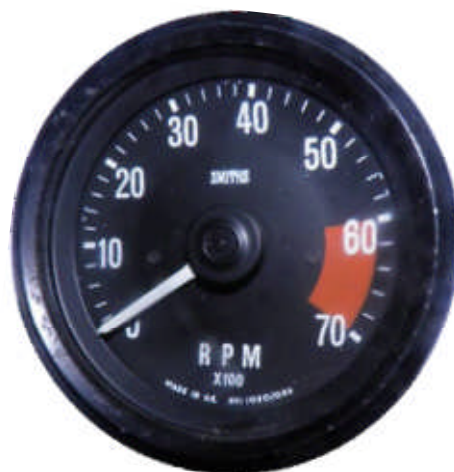
FIGURE 4.3: Gen-2 RVI 5000 series tachometer

Smiths produced a plastic cased "pod-style" instrument in the Gen-2 range. This was the RVI 5000 series accessory tachometer and is shown in *fig. 4.3* at right. **Contrary to what was written in earlier versions of this guide, this tachometer is only suitable for use on vehicles with 12 Volt electrical systems.**

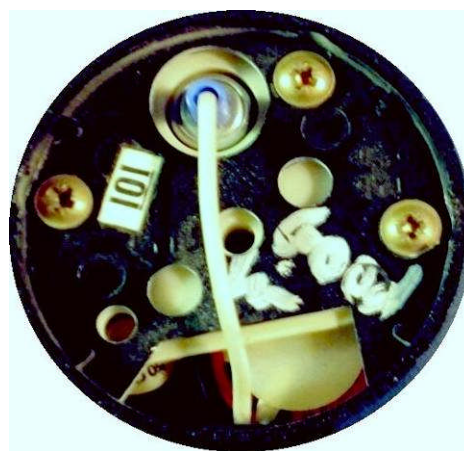
FIGURE 4.4: RVI 5000 series tachometer. At left is the rear view of an accessory tachometer, with the rear cover removed and showing the cylinder select terminals. **The blue wire is the -12V connection for 4 & 6 cylinder engines, the brown wire for 8 cylinders. Not, as previously written, for voltage selection!** The black wire is the lead to the vehicle's earth connection and internally connects only to the barrel of the lamp holder. Ensure that the connectors on the Blue and Brown wires do not move and short together! The internals are electrically isolated from the car and a green wire is provided as a dedicated earth for the light and is to be connected to the car's chassis.

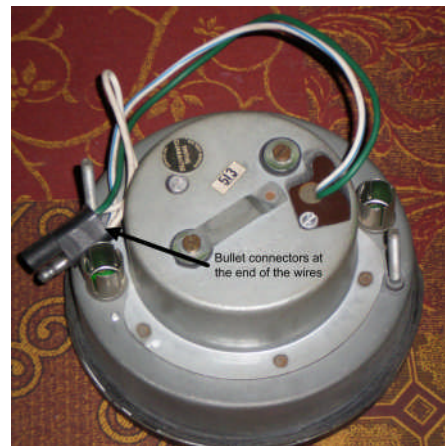
FIGURE 6.2: Jaguar Gen-3 RVC tachometer. Photograph courtesy of Mark Olson, Accutach.

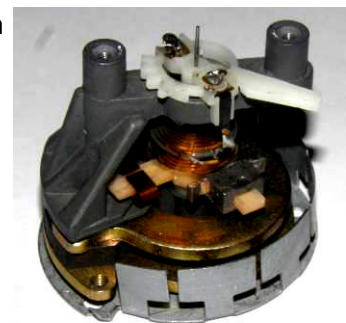
Fig. 6.5 below shows the rear of the "accessory" type Gen-4 tachometer. As with earlier accessory instruments, the electronics inside are electrically isolated from the case.

Note the white selector switch next to the terminals. This selector switch is only found on Gen-4 instruments, Gen-3 RVC tachometers used a switch accessed through a hole in the rear of the case.

FIGURE 6.5: Rear view of Gen-4 accessory tachometer. Terminals at bottom with white cylinder select switch above. Wiring of terminals redrawn at right.

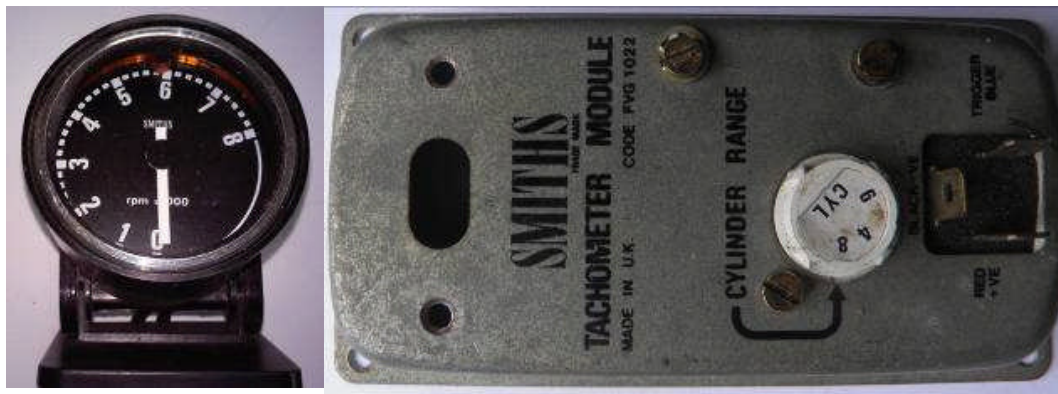
FIGURE 6.6: Gen-4 pod style tachometer comprising FVG 1021 head unit and separate FVG 1022 electronics module for mounting under dashboard.

Fig.6.6 shows the RVC range's answer to the RVI 5000 series instruments. This comprises a small indicator head designed to be mounted on a dashboard with adhesive pads fitted to the base. Four wires (2 for meter, 2 for lighting) lead from the underside of the indicator head through a hole cut in the dashboard. All the electronics are housed in a rectangular metal case which is intended to be hidden behind the dashboard. Power and pulse connections are made at the electronics unit and are the same as those shown for the Gen-4 accessory tachometer above. A two-pin Cinch socket for connection to the indicator pod meter is provided and located in the hole above "SMITHS".

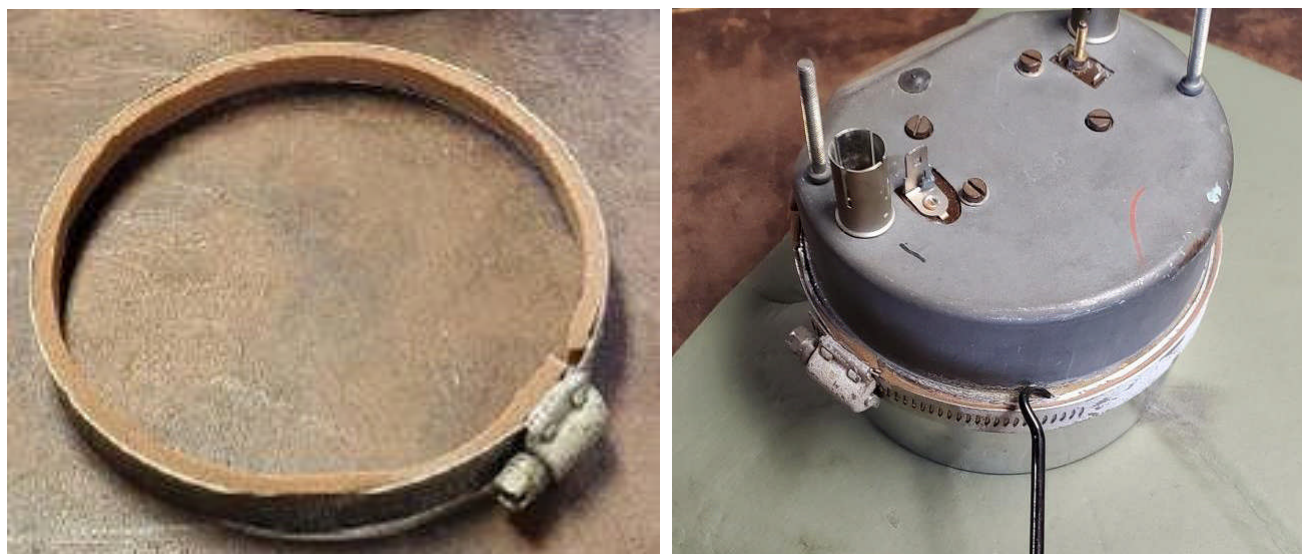
FIGURE C.1: Tool for removing spun-on bezel. A strip of adhesive backed foam rubber is stuck to a worm-drive hose clamp which is clamped around the rim of the bezel. The rubber is to protect the finish on the bezel itself. A blade screwdriver or similar is used to lift the spun over metal to remove the bezel. Right hand photograph shows tool fitted to a Volvo RVI 3410/00 tachometer.

Spun-on bezels, as used on 3" instruments, are not intended to be re-used. The official Smiths method of removal is to cut the bezel around and replace with a new one. Bezels can be reused once if care is taken. Some means of supporting the rim of the bezel is required for recovery to be successful. One such tool is shown in *fig. C.1* below.

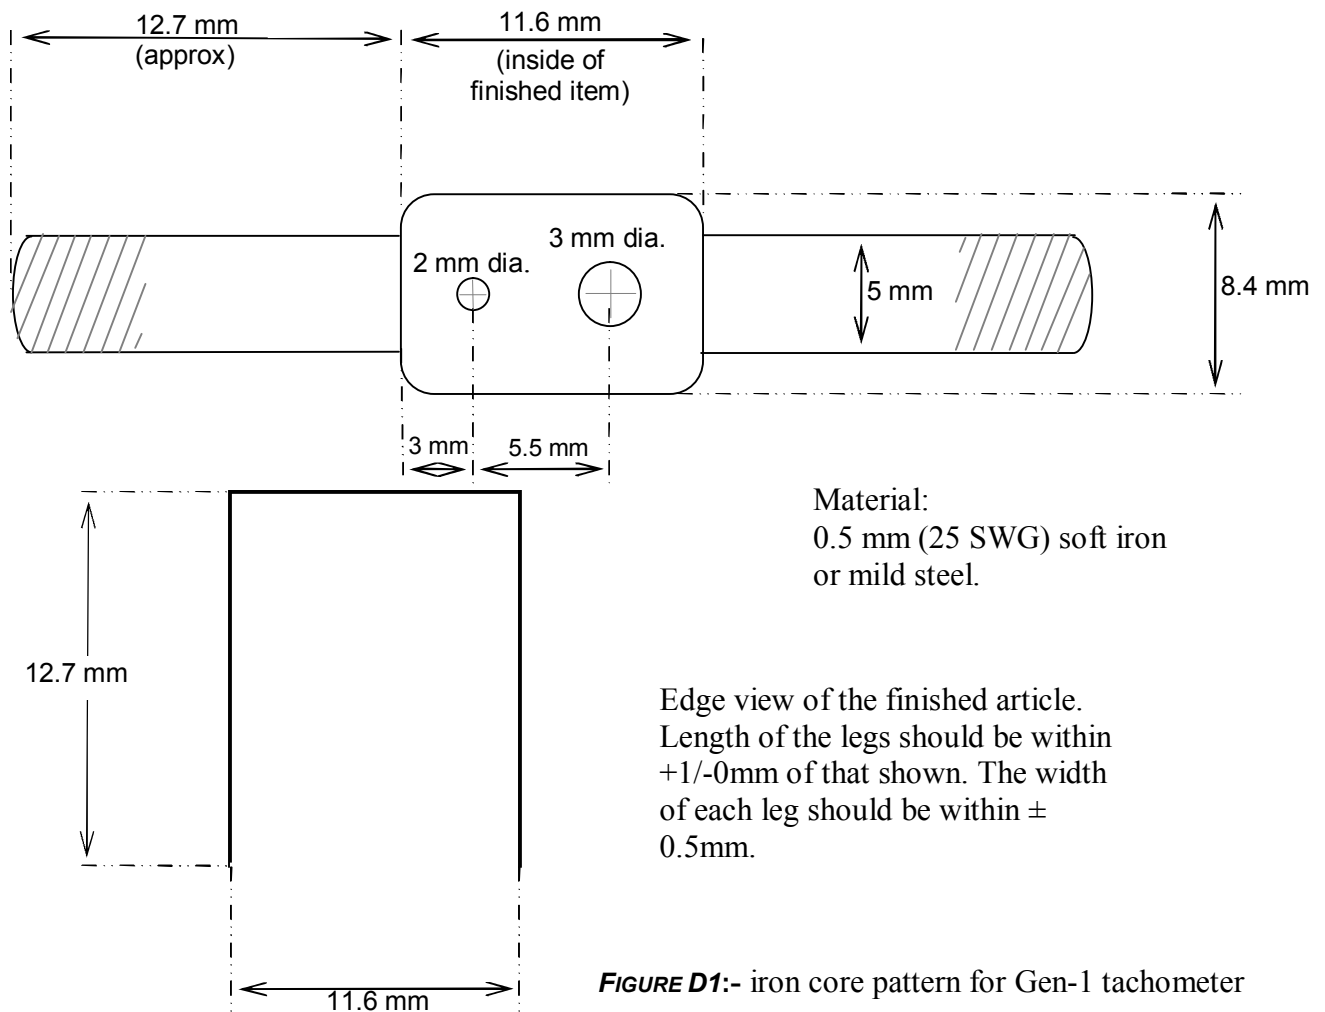
FIGURE D1:- iron core pattern for Gen-1 tachometer

Fig. D1 below shows the iron core of the Gen-1 tachometer. One can readily be made if required. Dimensions have been obtained from a Smiths item in good condition.

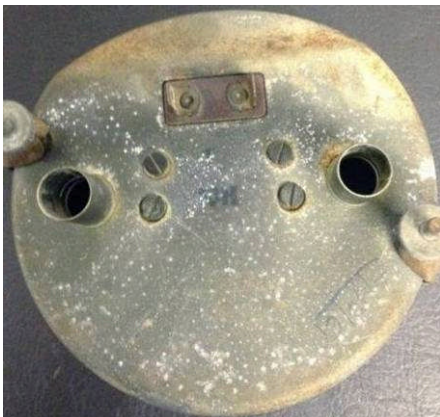
FIGURE F.1: Early pattern meter mountings vs later pattern. Note that dates provided with the above photos are best estimates and should be reasonably close, determined from vehicle production dates.

Pictures in *fig F.1* show the difference in the mounting hole patterns between the two meter styles – closer vertically spaced holes on the cases on the left with the wider spacing of the later meter shown to the right. The upper two photos were supplied by Phil Turnbull and show Jaguar tachometers. See his website †, which shows one of these tachometers along with a photograph of a custom electronic circuit board fitted.

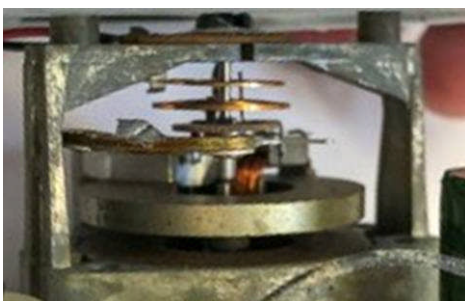
FIGURE F.2: Early meter assembly showing the die cast bridge that is part of the meter body casting. Circled area in right-hand picture shows solder added to the meter armature counterweight to balance the assembly.

Fig. F.2 shows the meter used in the earlier instruments. This is quite different to the later meter.

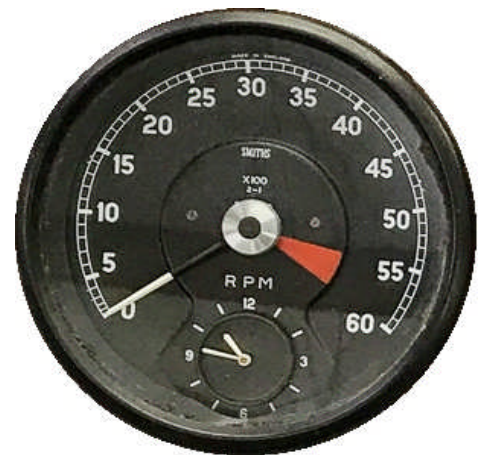
FIGURE F.3: Typical Smiths RV 7000 series tachometer. This one a RV 7403/00 from a 1962 Mk. II Jaguar. Photograph by Phil Turnbull, NZ

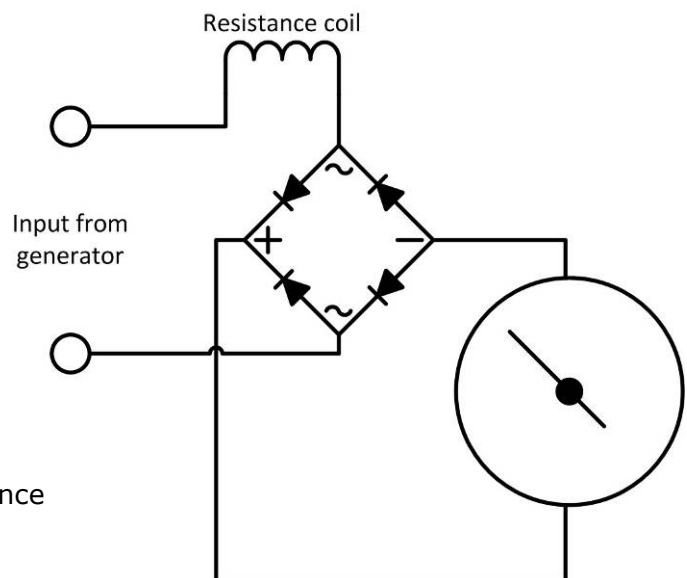
FIGURE F.4: Smiths RV (Gen-0) tachometer. This tachometer has the later style meter as shown at left and the electrical circuit diagram on the right. Photograph supplied by Phil Turnbull, NZ.
